PROJECT 41994 — REPORT

Erosion-Corrosion of Copper Pipes in Hot Water Reticulation Systems — Case Studies and Wider Implications

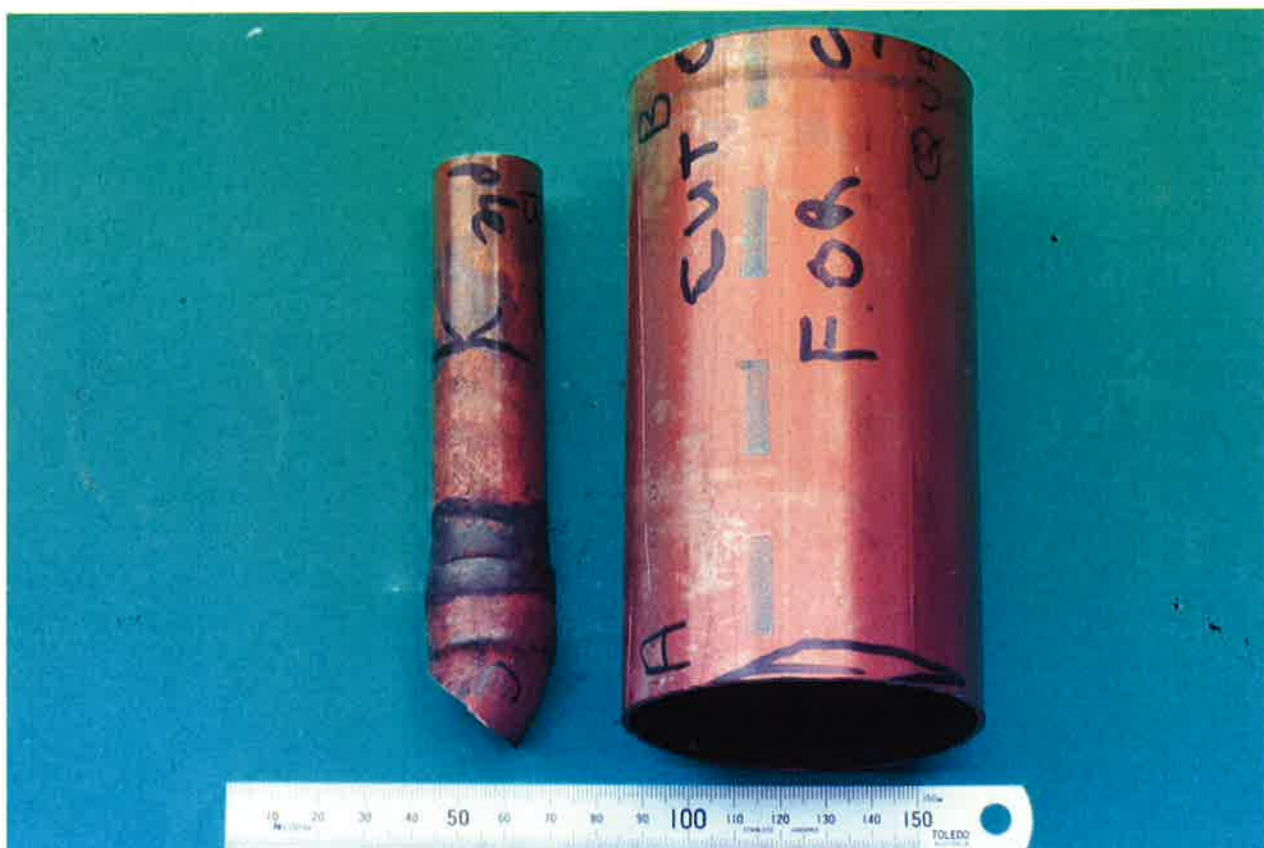
Two tube samples were provided to UQMP — one large diameter and one small diameter (see Figure 3 below). The smaller diameter tube showed clear evidence of Erosion-Corrosion (see Figure 4 and Figure 5). Characteristic features of Erosion-Corrosion seen in this sample included:

The larger diameter tube had no obvious signs of either Erosion-Corrosion or Pitting Corrosion.

Figure 3: Jacksons Landing, Quarry Building — Samples provided for examination.

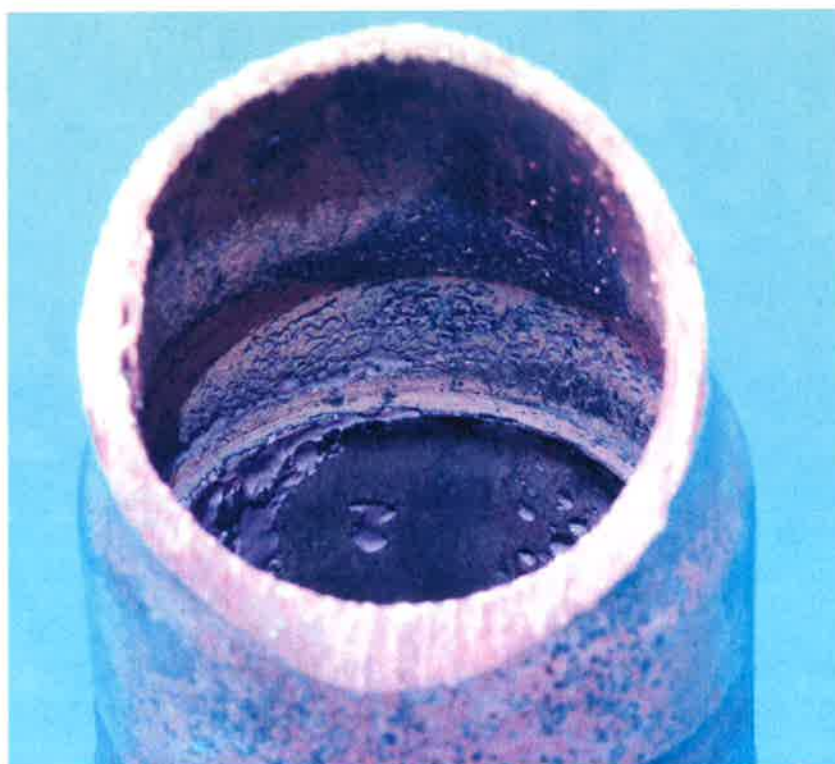
- Extensive regions of attack showing bare copper with no protective film;
- Islands of intact protective film, with undercutting;
- The regions of attack are associated with a joint which creates an internal step, hence turbulence;
- The joint also appears to be downstream from a bend in the tube.

*Figure 4(a): Jacksons Landing, Quarry Building — Smaller diameter tube before sectioning.
Evidence of Erosion-Corrosion visible from the open end.*

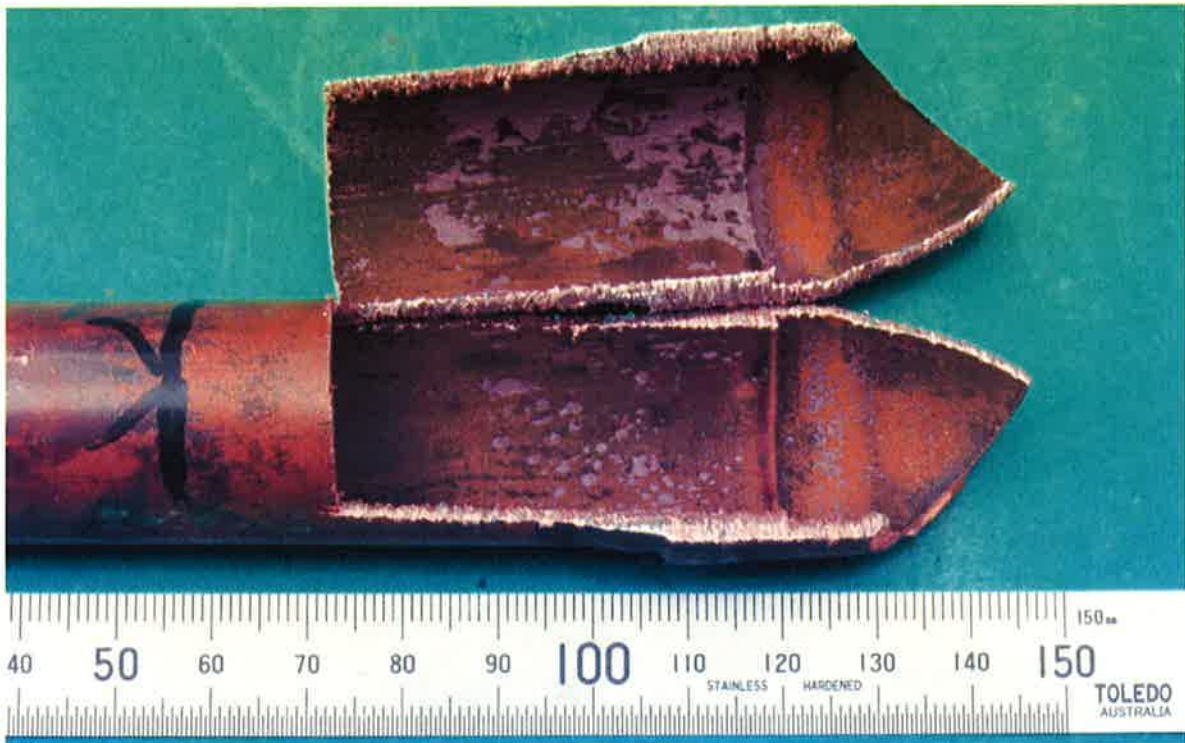
Figure 4(b): Quarry Building — Sample sectioned to reveal interior surfaces of tube.

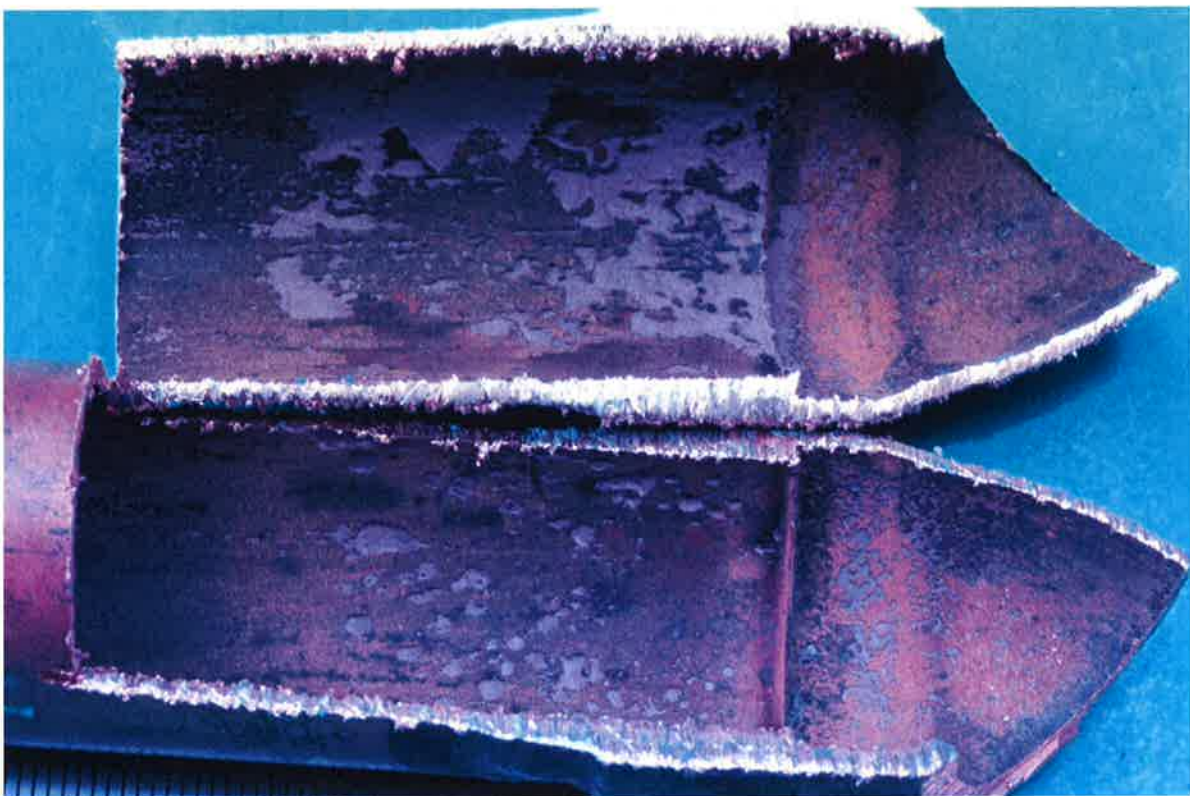
Figure 5: Jacksons Landing, Quarry Building — Closer view of Erosion-Corrosion attack on inner surface of tube; Extensive regions of bare metal in undercut pits and troughs between intact copper oxide scale; Distribution of attack suggests the role of turbulence associated with the joint.

The examination of the provided samples revealed one case of severe Erosion-Corrosion. The occurrence of even one example of Erosion-Corrosion of this level of severity raises a strong suspicion that water velocities are too high in the system.

However, bends and joints are only capable of triggering Erosion-Corrosion if the water velocity is systemically excessive. These local geometric features only magnify the effects of generally high water velocities.

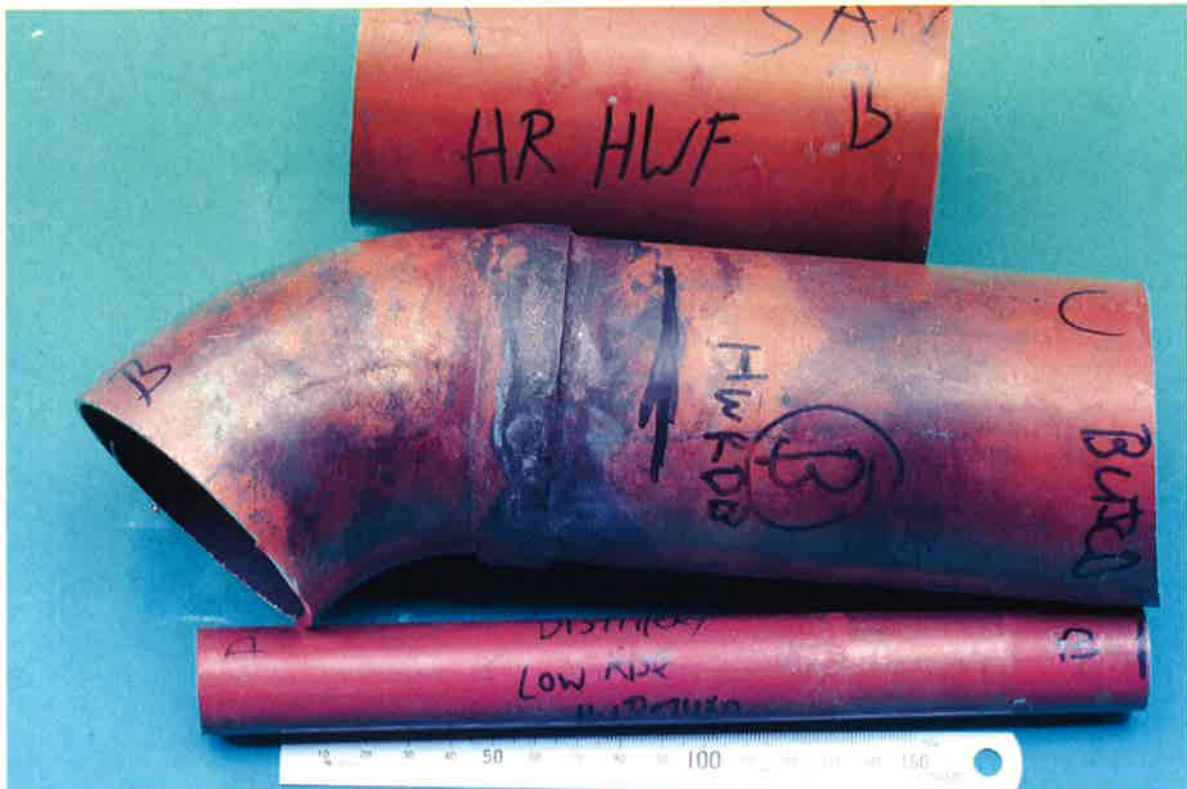
Three samples were provided, two large diameter and one small (see Figure 6). The small diameter tube was a straight section with neither bends nor joints.

None of the three samples showed any obvious signs of Pitting Corrosion or Erosion-Corrosion.

Figure 6: Jacksons Landing, Distillery Building — Samples provided for examination.

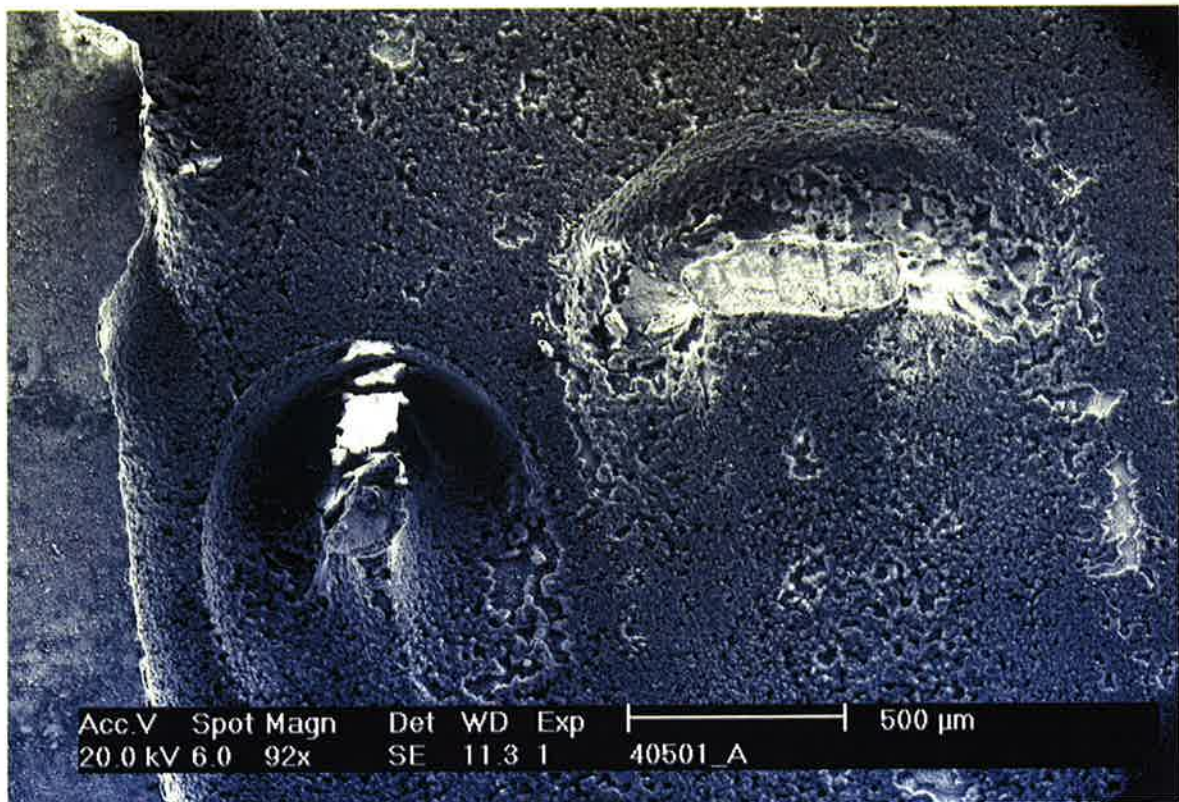
The Erosion-Corrosion attack was most severe at poorly profiled joints, and at bends, but was not restricted to these locations. UQMP was not informed of the water velocities or temperatures, but the widespread nature of the Erosion-Corrosion attack indicated systemically excessive velocities and/or temperatures.

Figure 7(a): Nursing Home — Horseshoe-shaped pits within a longitudinal trough; Remaining scale-protected surface visible at left. SEM secondary electron image.

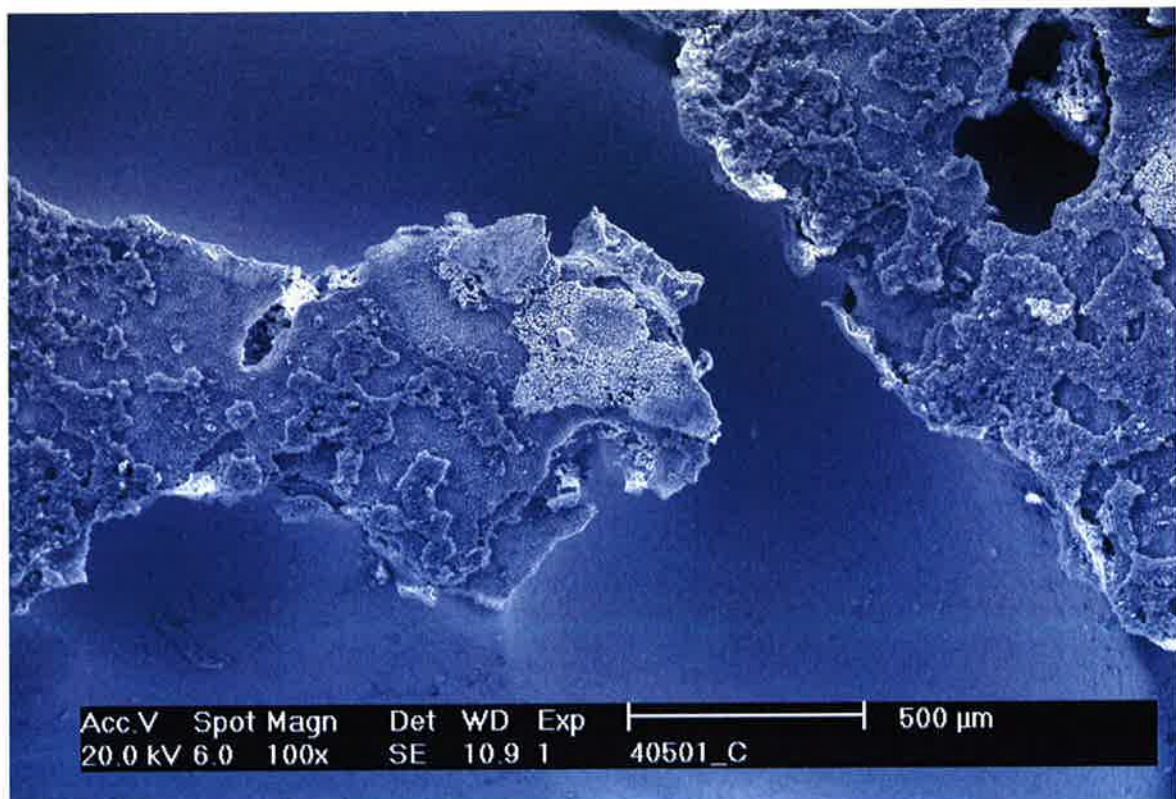
Figure 7(b): Nursing Home — Planar scale-protected surface and deeply undercut pits.

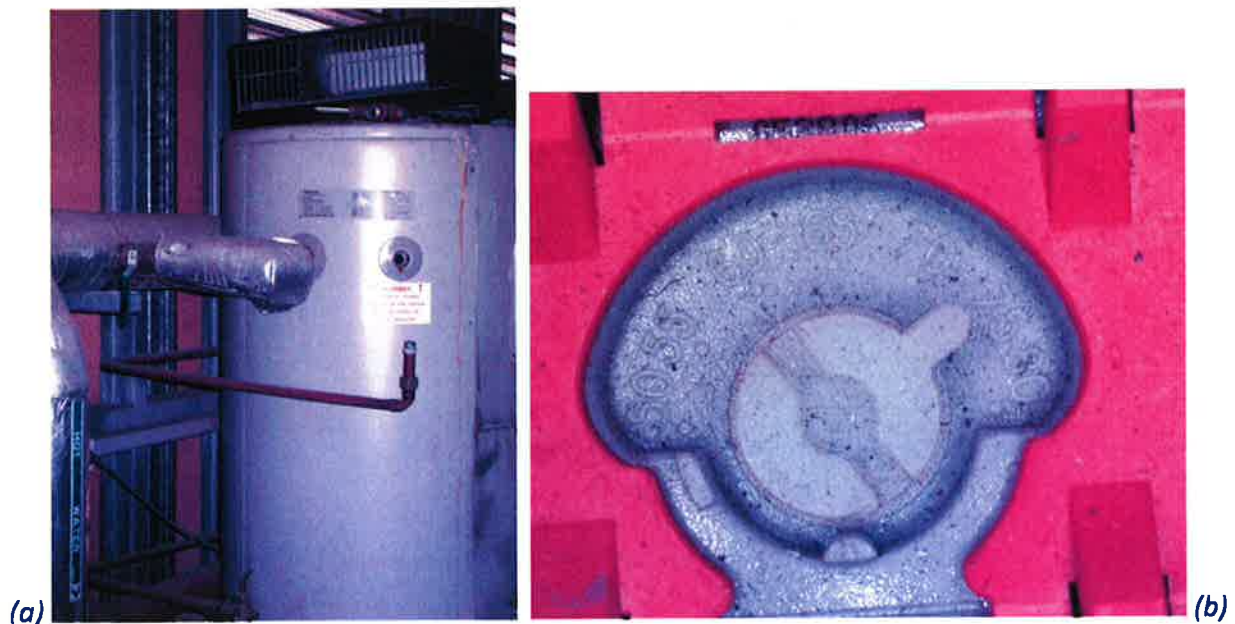
Figure 8(a) shows one of the water heaters. Figure 8(b) shows one of the temperature controllers, which appears to be set to about 73°C. From the seven water heaters that were operational at the time of inspection, outlet temperatures were measured to range from 54°C to 80°C.

Figure 8: Brisbane residential tower water heater and temperature controller. The controller appears to be set to about 73°C.

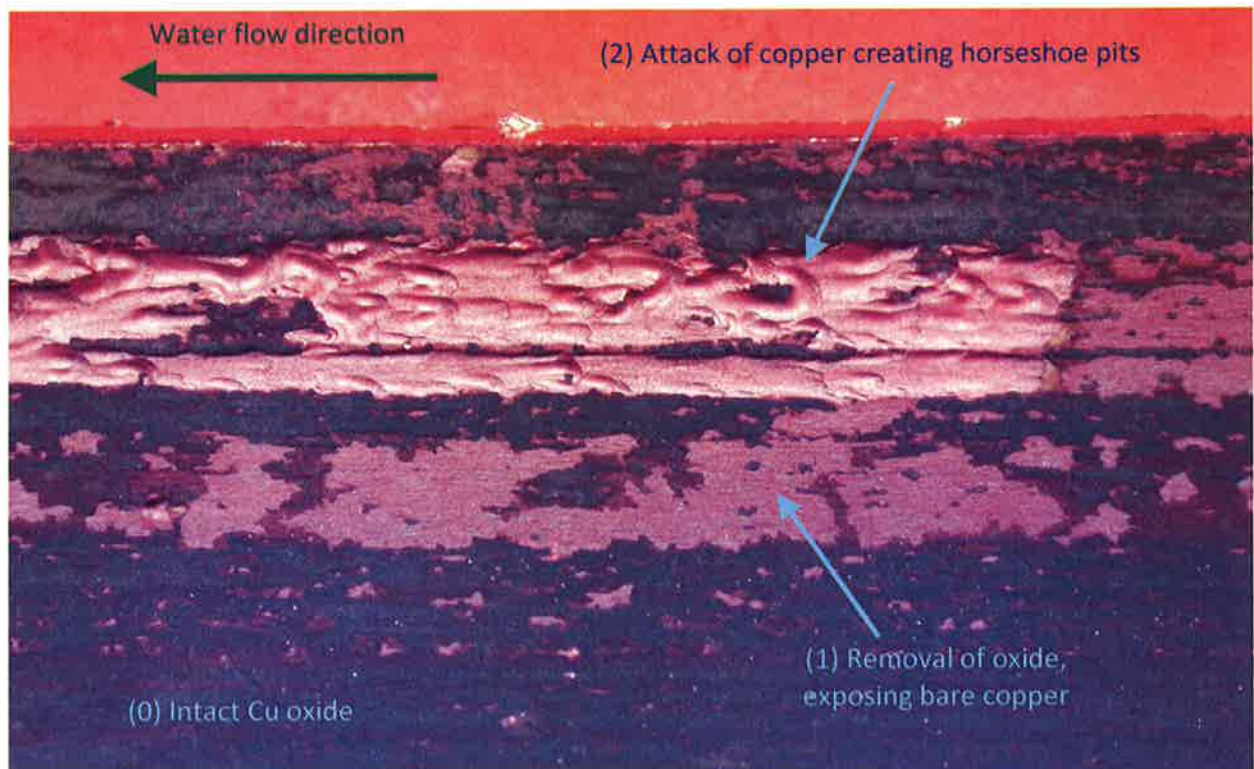
Figure 9(a): Brisbane residential tower — Early stages of Erosion-Corrosion attack; Horseshoe-shaped pits have open end downstream.

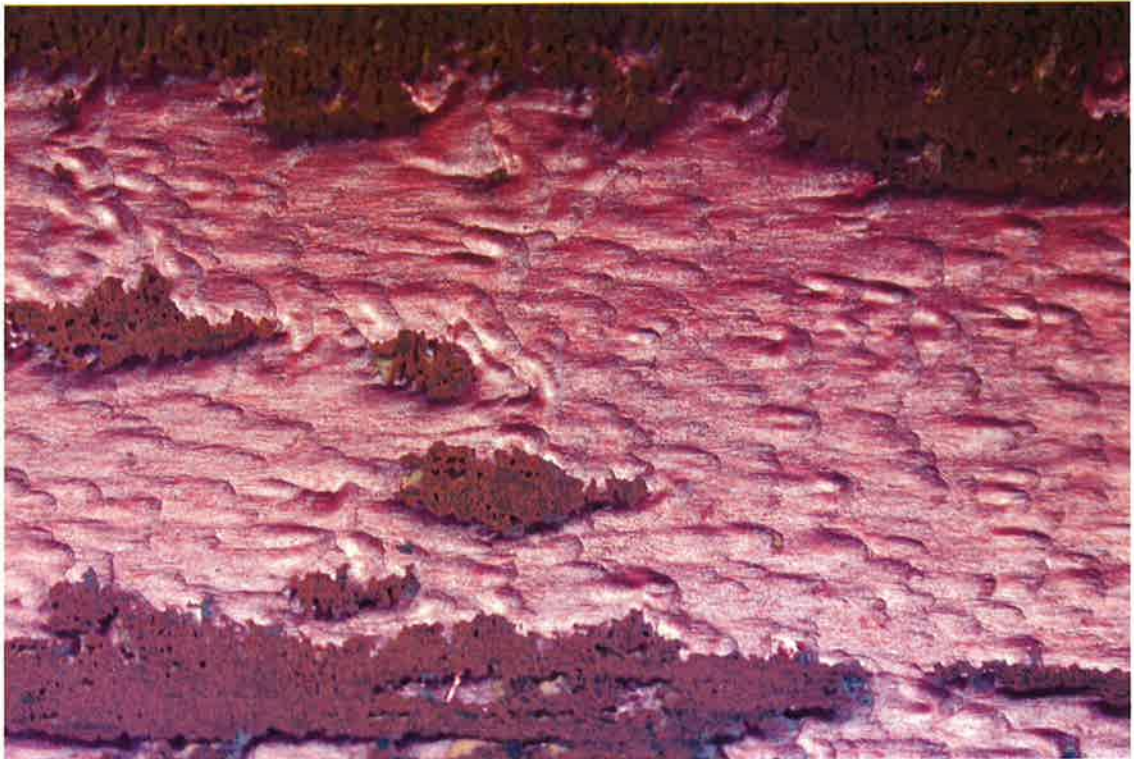
Figure 9(b): Brisbane residential tower — Detail of Erosion-Corrosion, showing coalescence of horseshoe-shaped pits, undercutting islands of intact oxide/carbonate/sulphate.

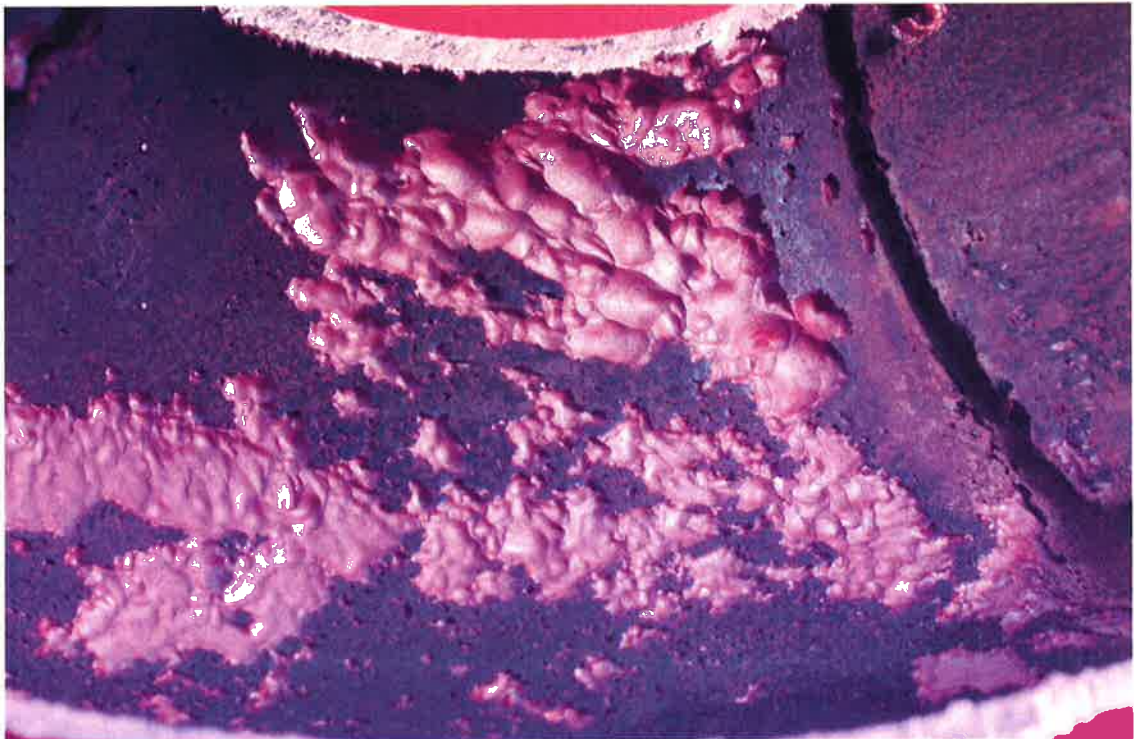
Figure 9(c): Brisbane residential tower — Erosion-Corrosion associated with turbulence downstream of a joint.

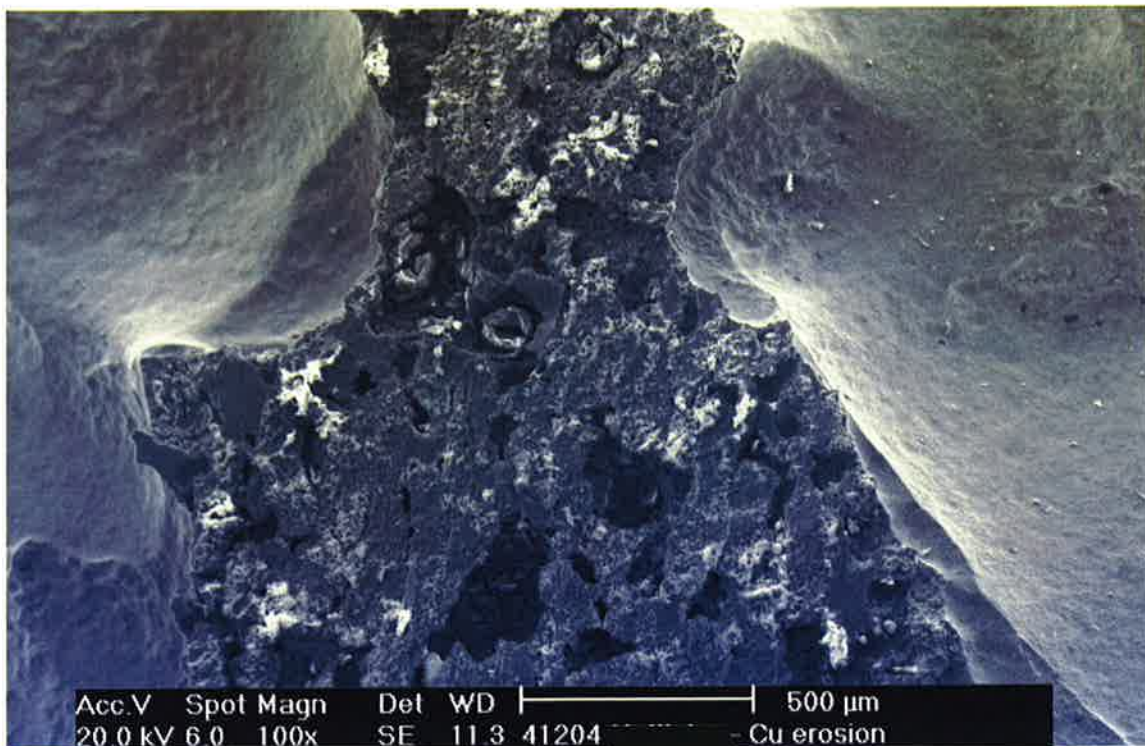
Figure 10: Brisbane residential tower — Island of oxide/carbonate/sulphate scale, with Erosion-Corrosion pits on either side. SEM secondary electron image.

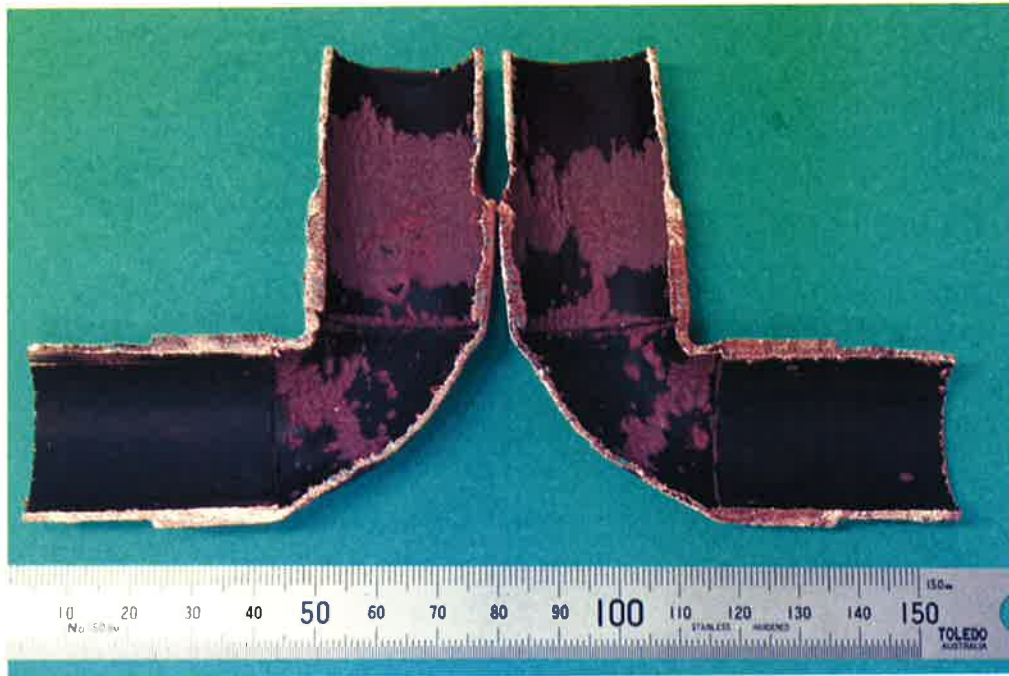
The sample (see Figure 11) showed the characteristic features of Erosion-Corrosion:

- Extensive regions of attack showing bare copper with no protective film;
- Islands of intact protective film, with undercutting;
- These regions being associated with a bend and joints which create turbulence.

Figure 11: Admiralty Apartments — Regions of Erosion-Corrosion associated with bend and joint.
