PROJECT 41994 — REPORT

Erosion-Corrosion of Copper Pipes in Hot Water Reticulation Systems — Case Studies and Wider Implications

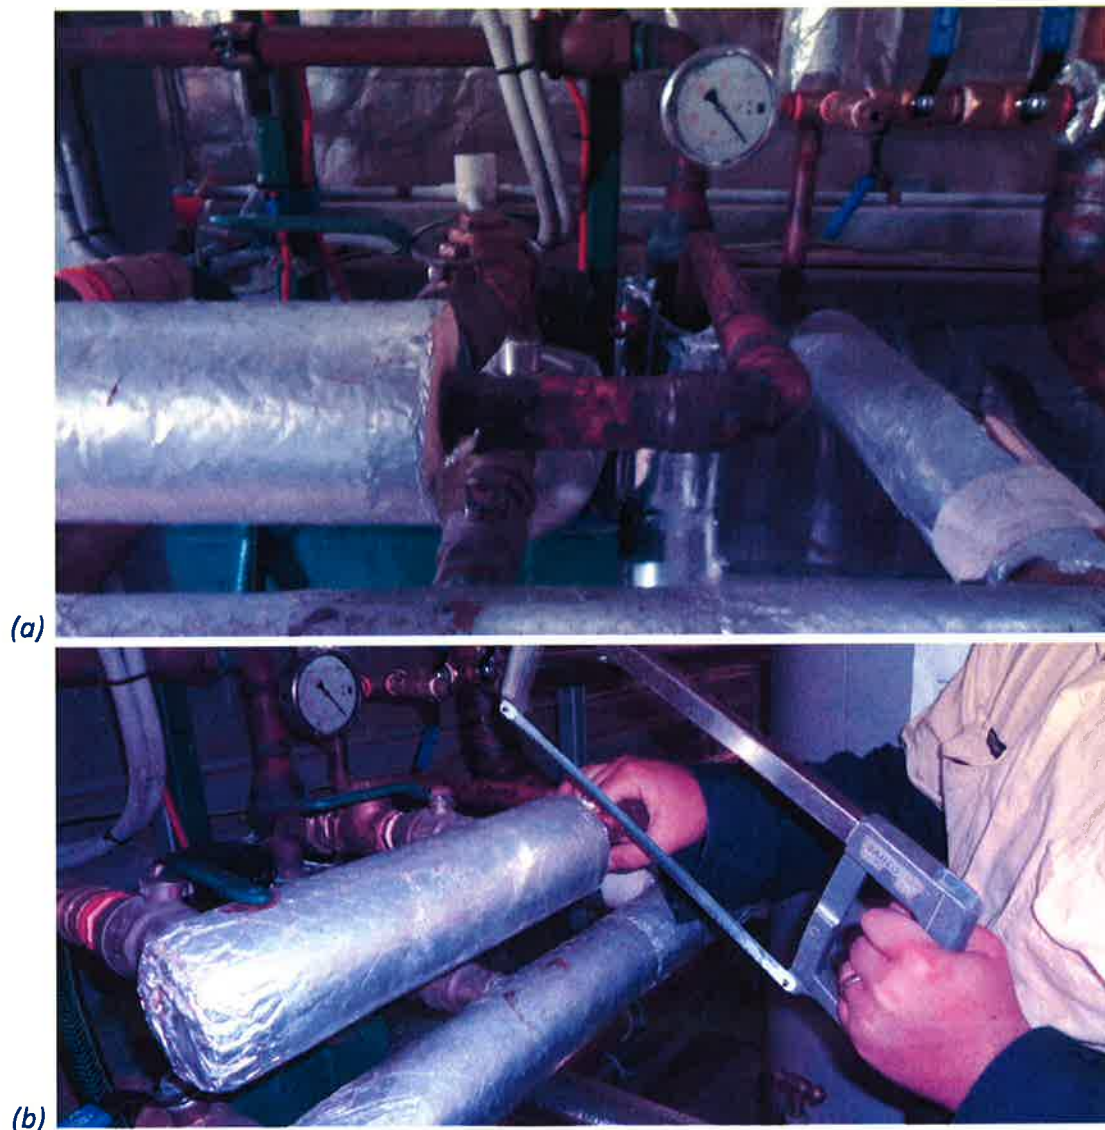
Figure 1: Cropped reproductions of photographs provided by Aquatherm showing pipe samples being cut from Jacksons Landing, Quarry Building.

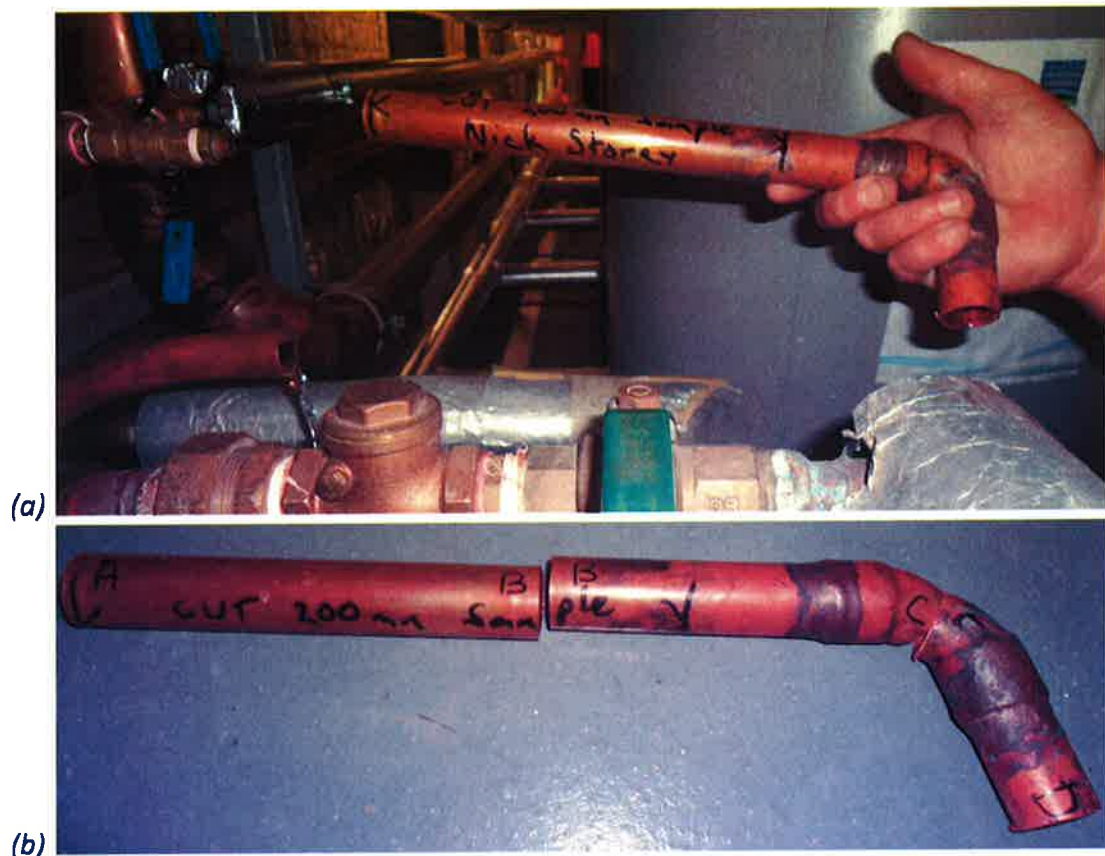
Figure 2: Cropped reproductions of photographs provided by Aquatherm showing pipe samples after cutting from Jacksons Landing, Quarry Building.
